CONNECTICUT RIVER BASIN DURHAM , CONNECTICUT

YMCA POND DAM CT 00385

PHASE I INSPECTION REPORT NATIONAL DAM INSPECTION PROGRAM

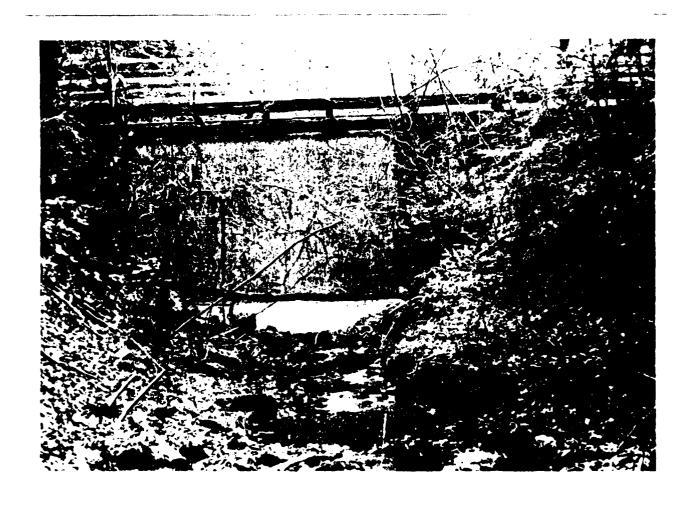
OVERVIEW PHOTO YMCA Pond Dam

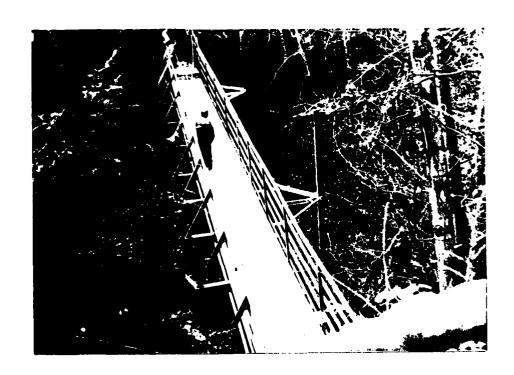
- f. Footbridge. A wood footbridge spans the crest of the dam as shown in Photos No. 2 and No. 3. The footbridge is supported by wood blocks attached to the concrete crest by metal angle sections. There is one foot clearance from the crest of the dam to the bottom of the footbridge. The footbridge is in fair condition. Most wooden members of the structure are sound with the exception of several wood supports near the right abutment.

PHOTO #2: Top of dam from left abutment

The footbridge causes a potential for collecting debris and restricting flow. Consideration should be given to raising the bridge to provide adequate clearance over the crest of the dam.

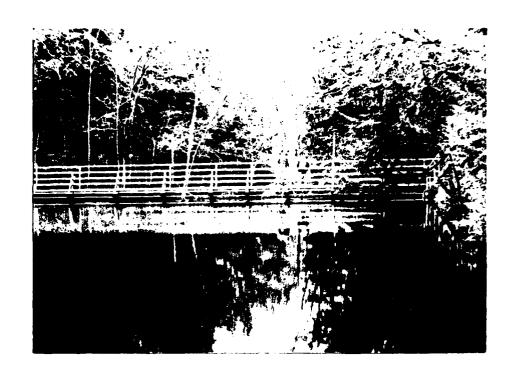
PHOTO #3: Upstream face of dam

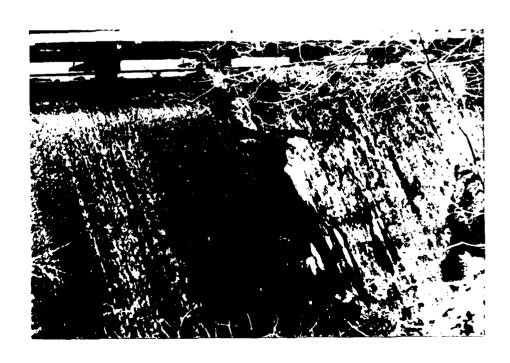
PHOTO #8: Downstream face from right abutment
